REPORT NO. DPS/TS1-200/19

RELATIVE EFFECTIVENESS OF TNT,
COMPOSITION B, AND H6 AS MINE FILLERS (U)

Nineteenth Report on Ordnance Project No. TS1-200

OCTOBER 1959

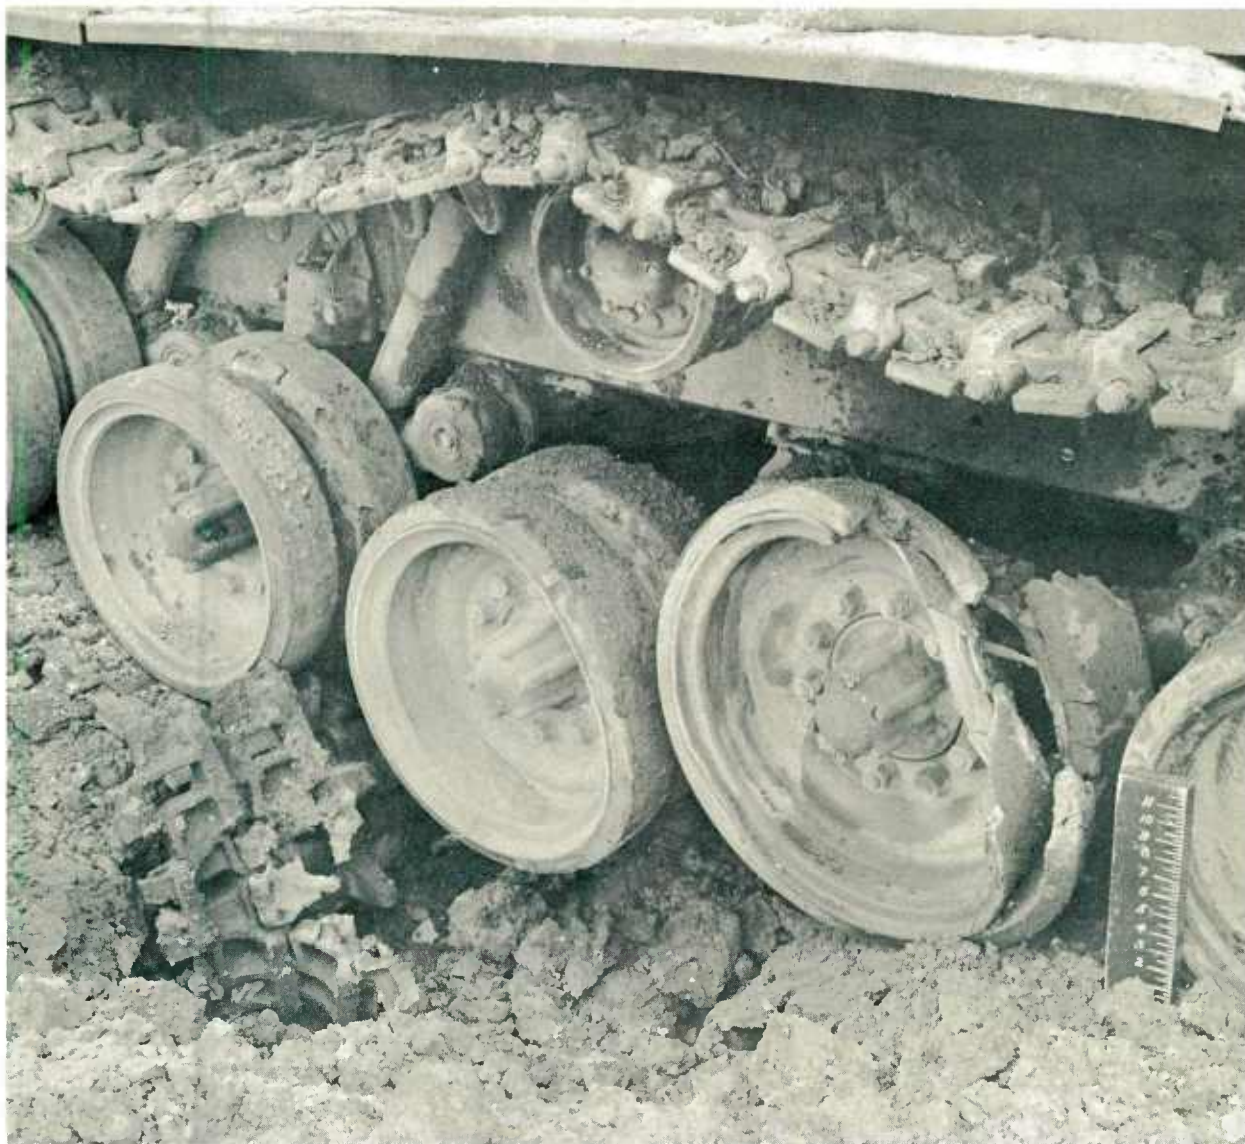
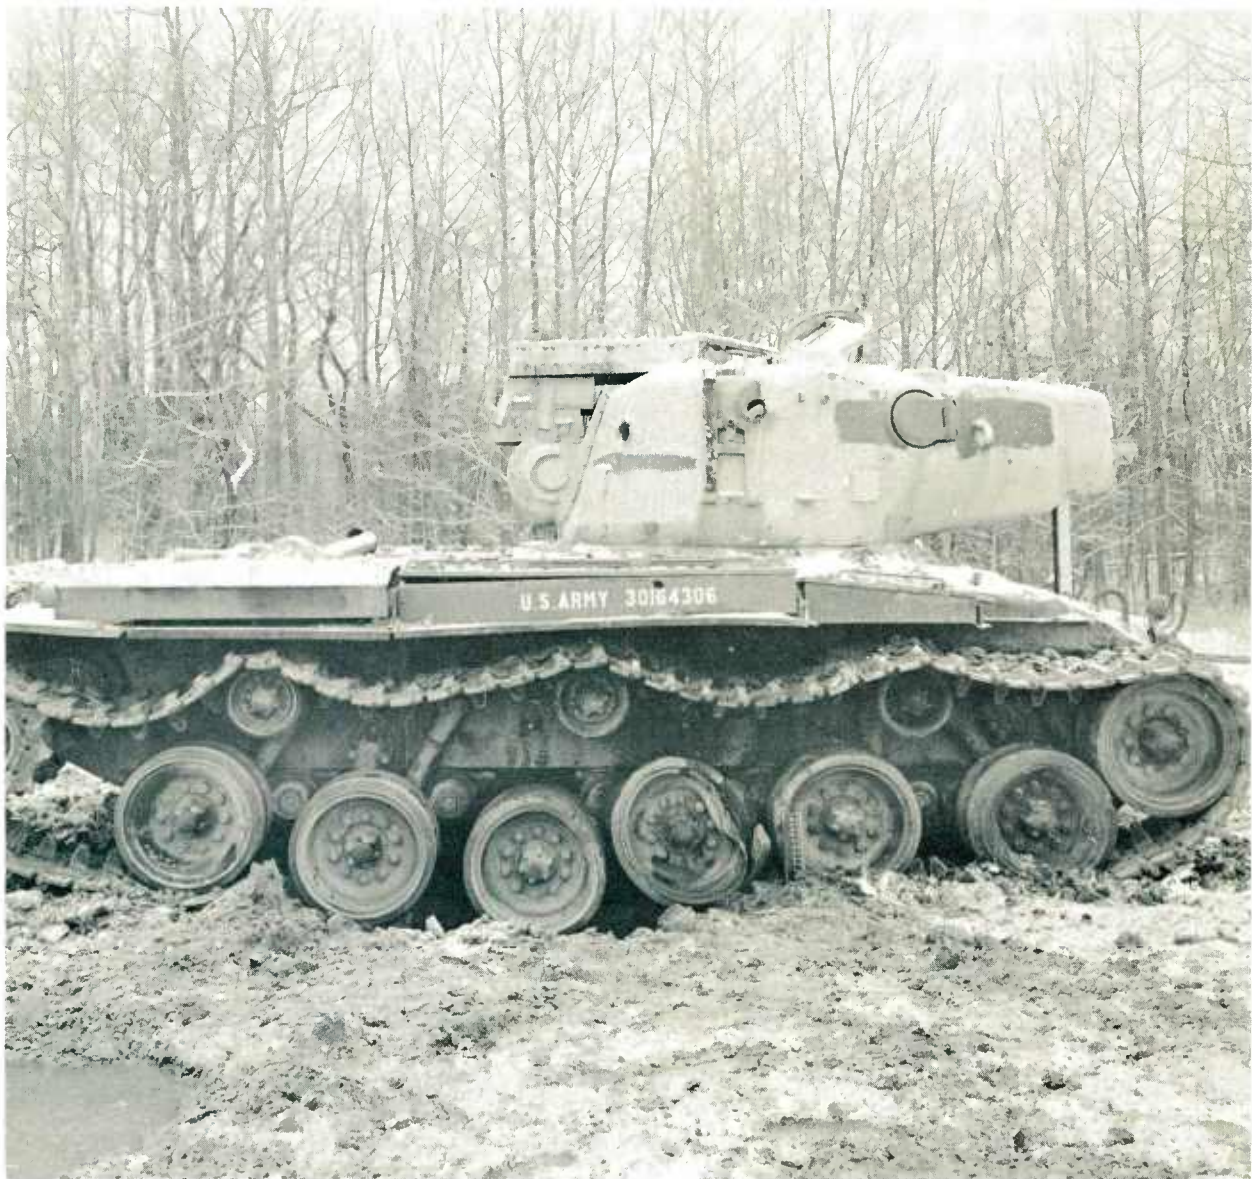
59T577: Close-up of Right Side of U.S. M47 Tank, No. 30164306 After Detonation of Charge No. 8 Under Centerline of No. 3 Road Wheel Under the Lateral Center of the JSIII Track. Charge Consisted of 7.94 Pounds of Comp B Encased in an 8.5-Inch Diameter Cylindrical 24-Gauge Galvanized Container. Emplaced with 3-Inch Soil Cover.

59T578: General View of Right Side of U.S. M47 Tank, No. 30164306 After Detonation of Charge No. 8 Under Centerline of No. 3 Road Wheel Under the Lateral Center of the JSIII Track. Charge Consisted of 7.94 Pounds of Comp B Encased in an 8.5-Inch Diameter Cylindrical 24-Gauge Galvanized Container. Emplaced with 3-Inch Soil Cover.

Results (C): Track severed. Three track shoes were blown out of the track, two of them were broken in half, the other was badly bent. Two other shoes were slightly bent. No. 3 road wheel destroyed. Numbers 3 and 4 bumper spring assembly sheared from hull. The results are shown in AFG photographs No. 59T577 and 59T578, in Appendix C.

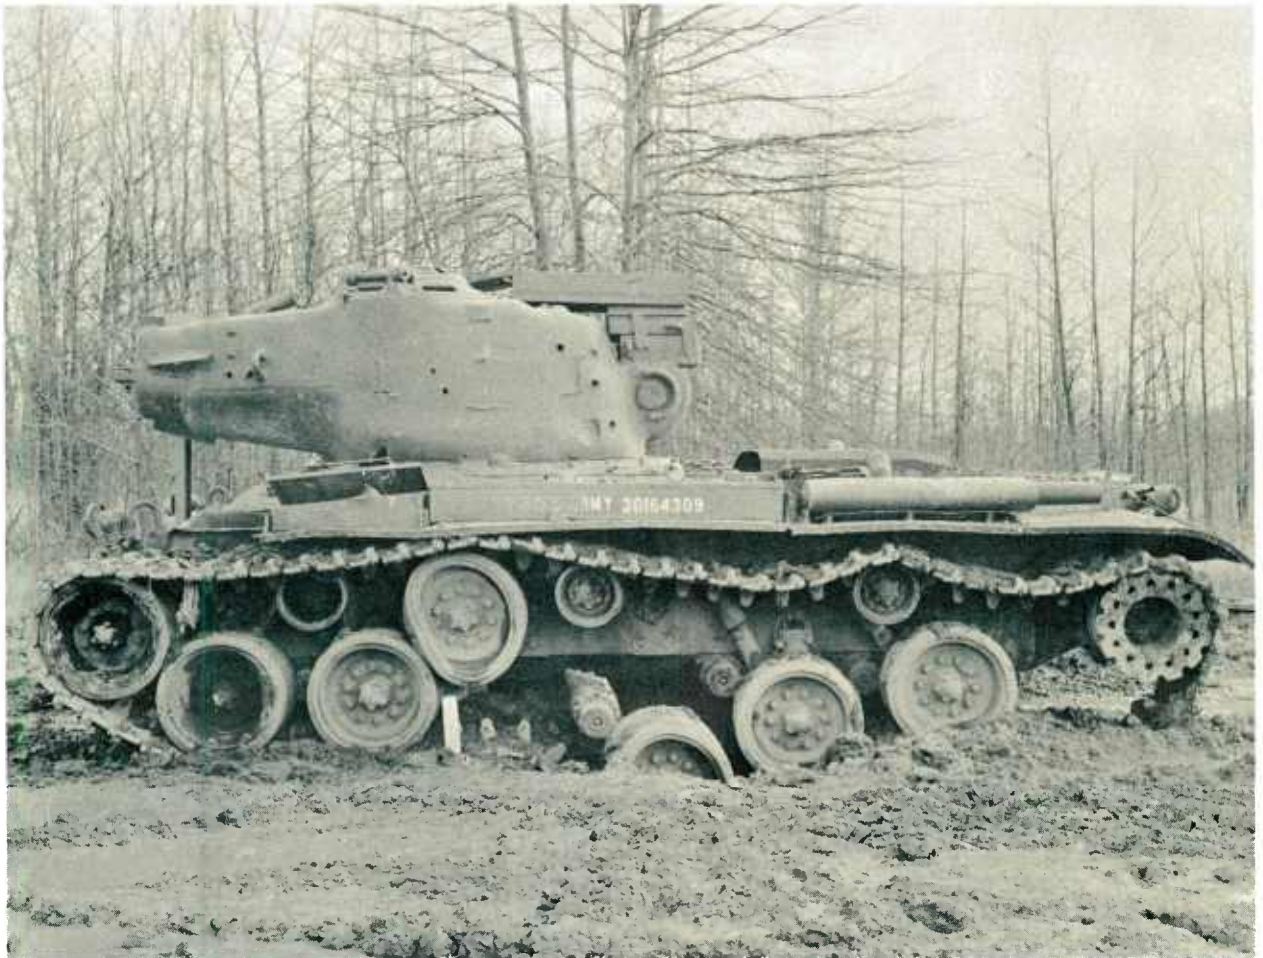
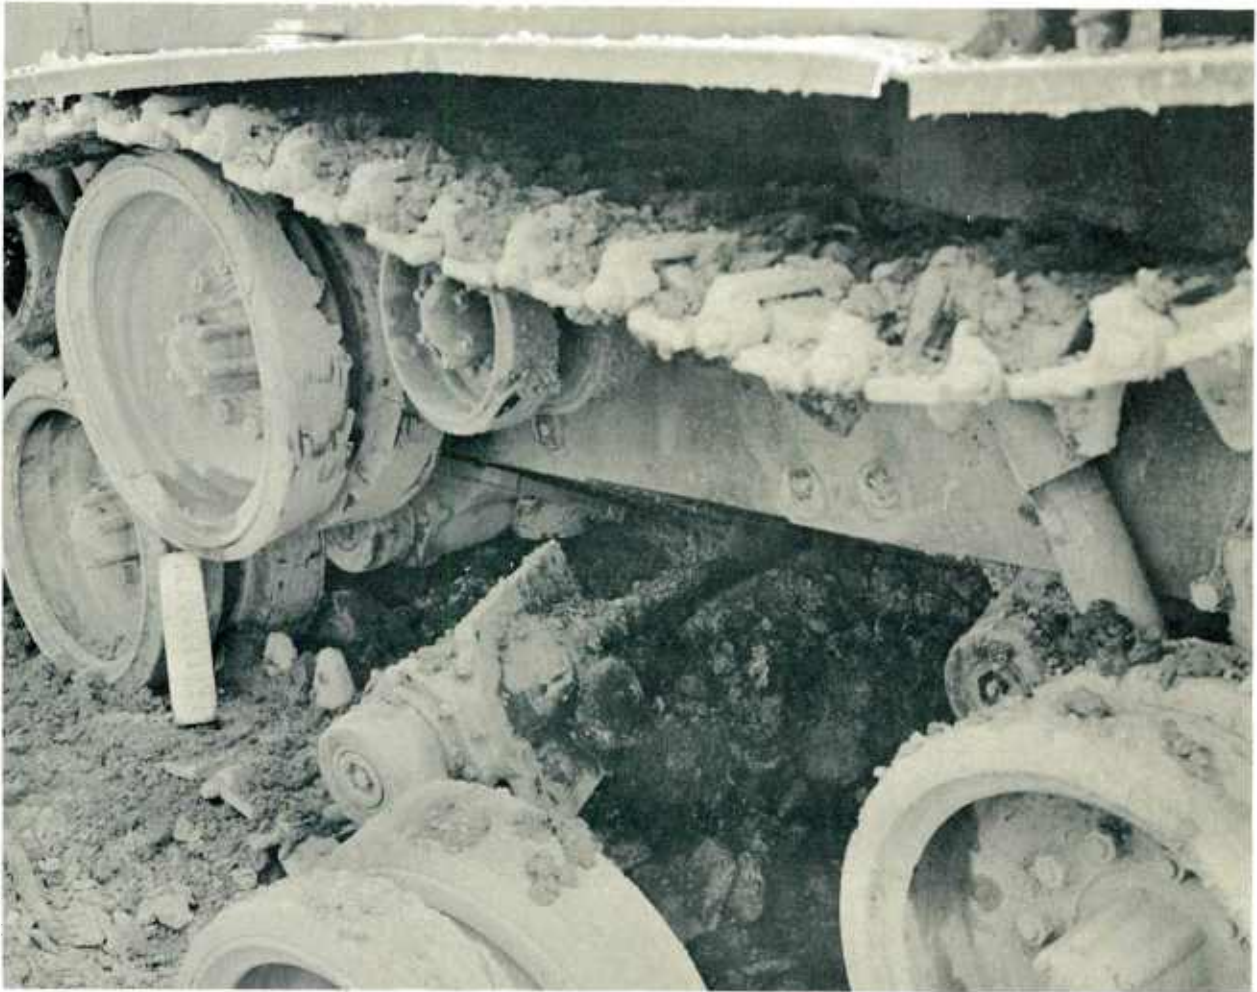
59T613: General View of Left Side of U.S. M47 Tank, No. 30164309
After Detonation of Charge No. 9 Under Centerline of No. 3 Road Wheel
Under Lateral Center of the JSIII Track. Charge Consisted of 6.99 pounds
of Comp B Encased in an 8.5-Inch Diameter Cylindrical 24-Gauge Galvanized
Container. Emplaced with 3-Inch Soil Cover.

59T614: Close-up of Left Side of U.S. M47 Tank, No. 30164309 After Detonation of Charge No. 9 Under Centerline of No. 3 Road Wheel Under Lateral Center of the JSIII Track. Charge Consisted of 6.99 Pounds of Comp B Encased in an 8.5-Inch Diameter Cylindrical 24-Gauge Galvanized Container. Emplaced with 3-Inch Soil Cover.

Results (C): Track severed. Two shoes badly bent and broken at the hinge sections. Three others slightly bent and cracked at the hinge sections. Numbers 3 and 4 road wheel arm support assemblies blown loose from hull. No. 3 was still hanging by the studs but No. 4 was completely off. No. 3 road wheel destroyed. No. 4 shock absorber destroyed. Results are shown in AFG photographs No. 59T613 and 59T614 in Appendix C.

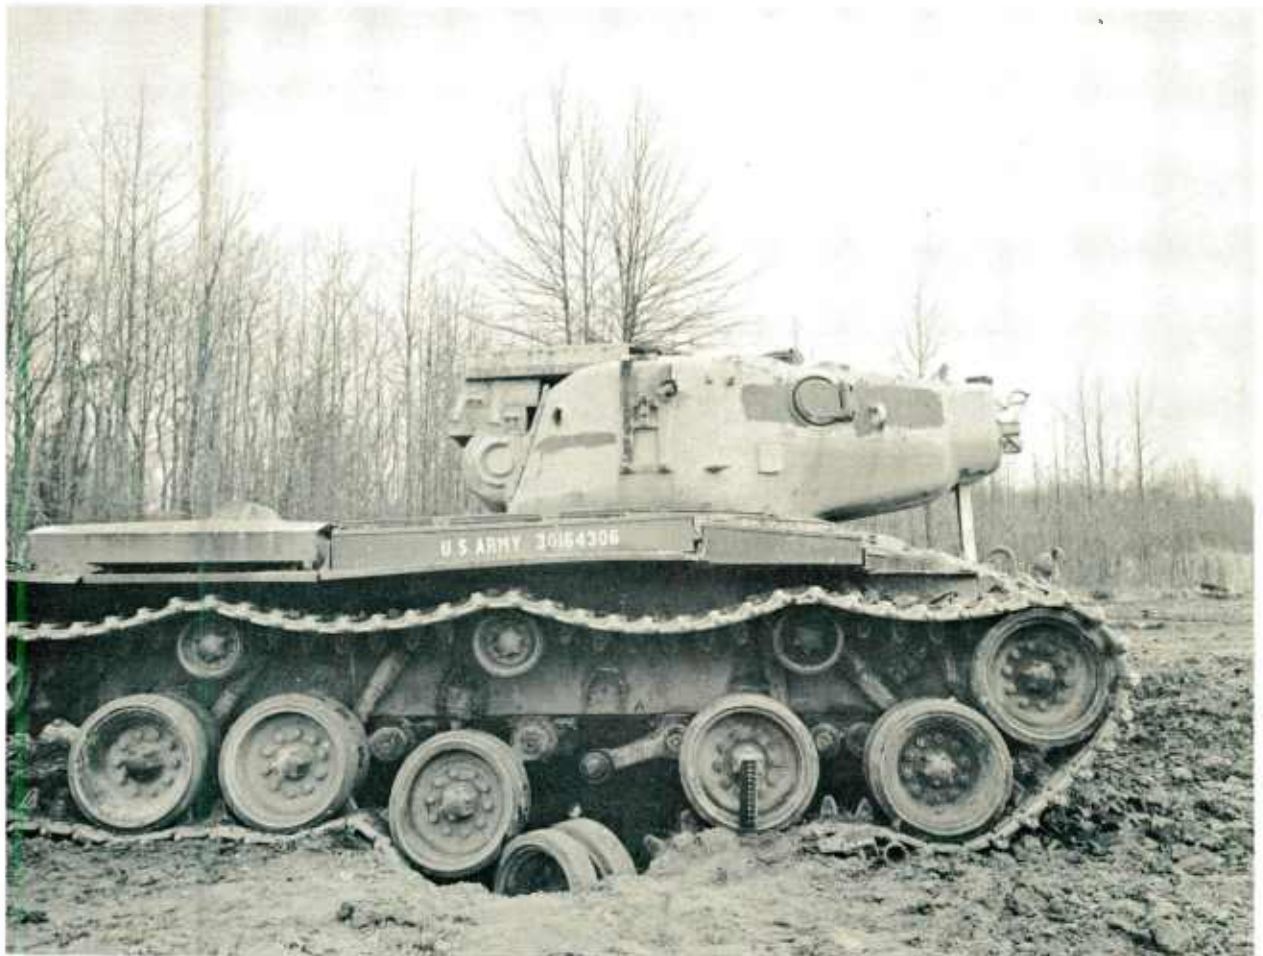
59P182: General View of Right Side of U.S. M47 Tank, No. 30164306, After Detonation of Charge No. 10 Under Centerline of No. 3 Road Wheel Under the Lateral Center of the JSIII Track. Charge Consisted of 5.01 Pounds of Comp B Encased in an 8.5-Inch Diameter Cylindrical 24-Gauge Galvanized Container. Emplaced with 3-Inch Soil Cover.

Results (C): Track severed. One track shoe blown in half, one other badly bent and broken at the hinge sections, and three others slightly bent and cracked at the hinge sections. No. 3 road wheel destroyed. No. 3 bumper spring assembly sheared from hull, spring and housing separated. No. 4 road wheel slightly bent. Results are shown in AFG photographs No. 59F182 in Appendix C, and 59F196 in Figure 9.

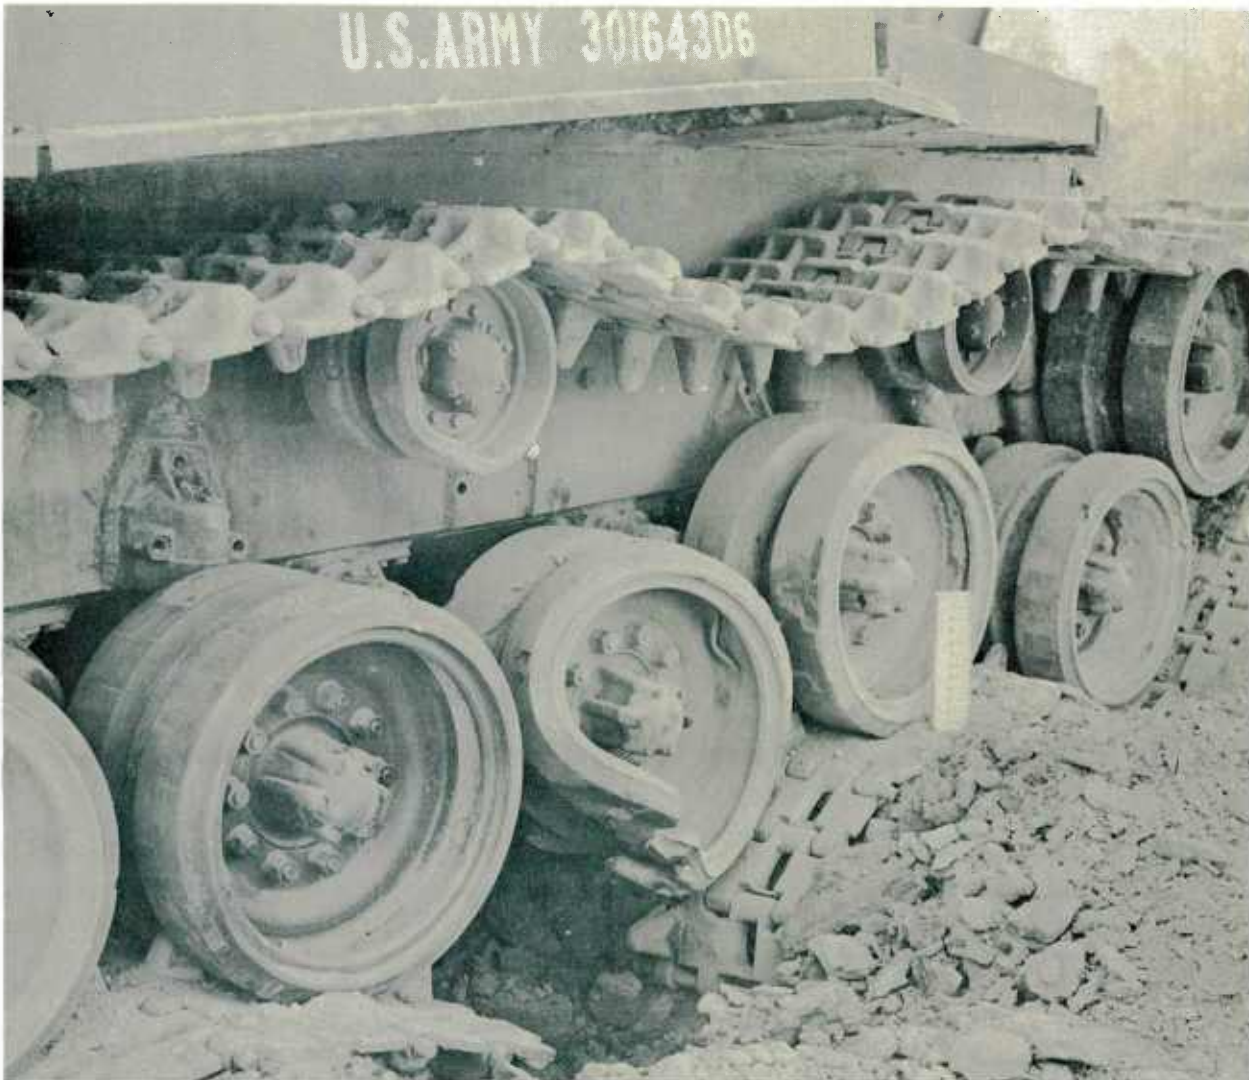
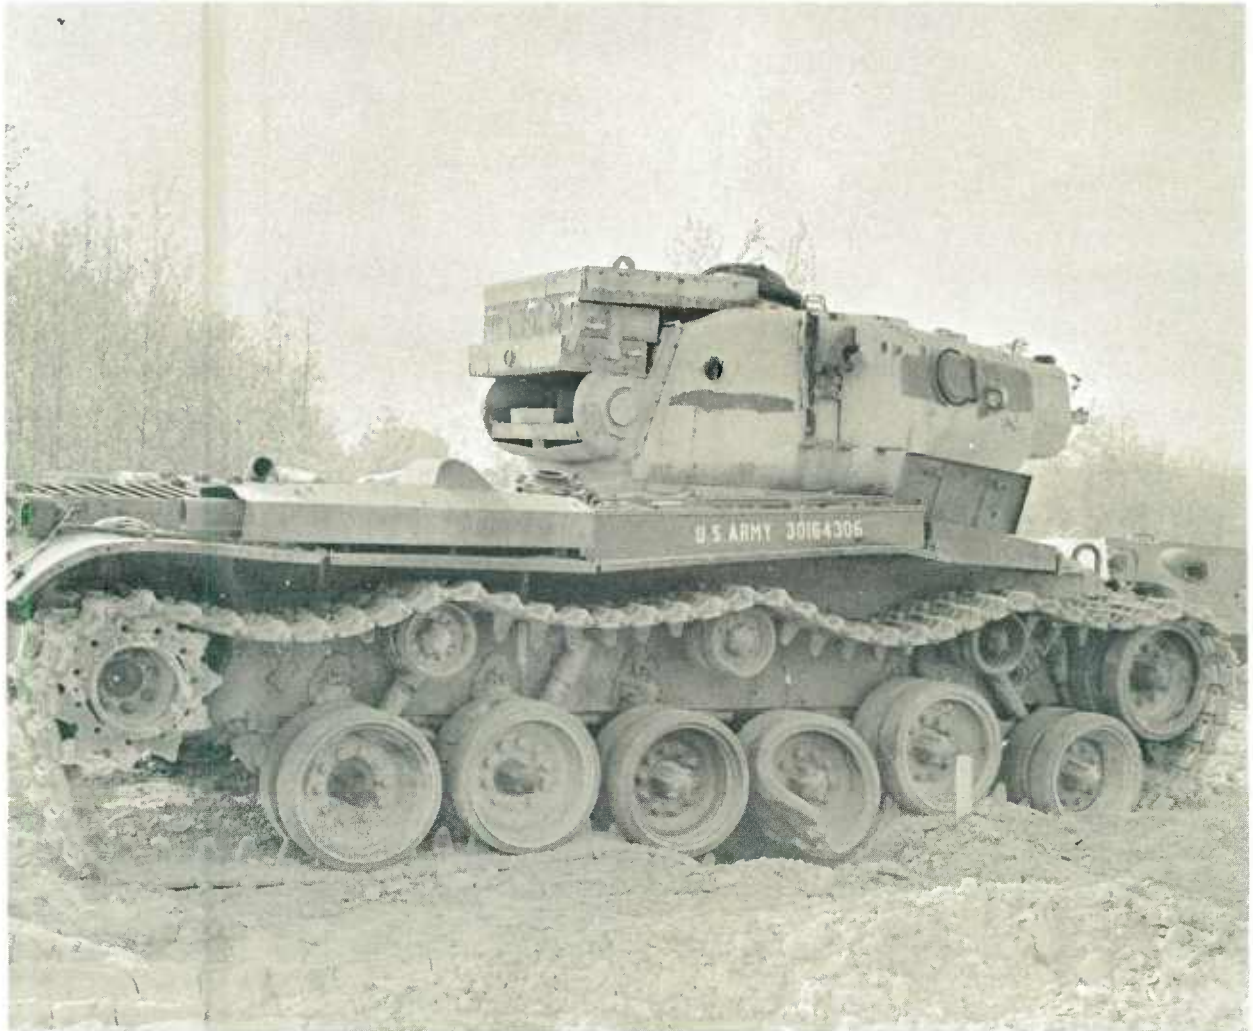
59T1728: Close-up of Right Side of U.S. M47 Tank, No. 30164306 After Detonation of Charge No. 16 Under Center Line of No. 3 Road Wheel Under the Lateral Center of the JSIII Track. Charge Consisted of 3.59 Pounds of the H6 Encased in an 8.5-Inch Diameter Cylindrical 24-Gauge Galvanized Container. Emplaced with 3-Inch Soil Cover.

59T1729: General View of Right Side of U.S. M47 Tank, No. 30164306 After Detonation of Charge No. 16 Under Centerline of No. 3 Road Wheel Under the Lateral Center of the JSIII Track. Charge Consisted of 3.59 Pounds of the H6 Encased in an 8.5-Inch Diameter Cylindrical 24-Gauge Galvanized Container. Emplaced with 3-Inch Soil Cover.

Results (C): Severed track. Two track shoes badly bent and broken at the hinge sections, one of them broken in half. Three others slightly bent with some cracks in hinge sections. No. 3 road wheel destroyed. Results shown in APG photographs No. 59T1728 and 59T1729 in Appendix C.

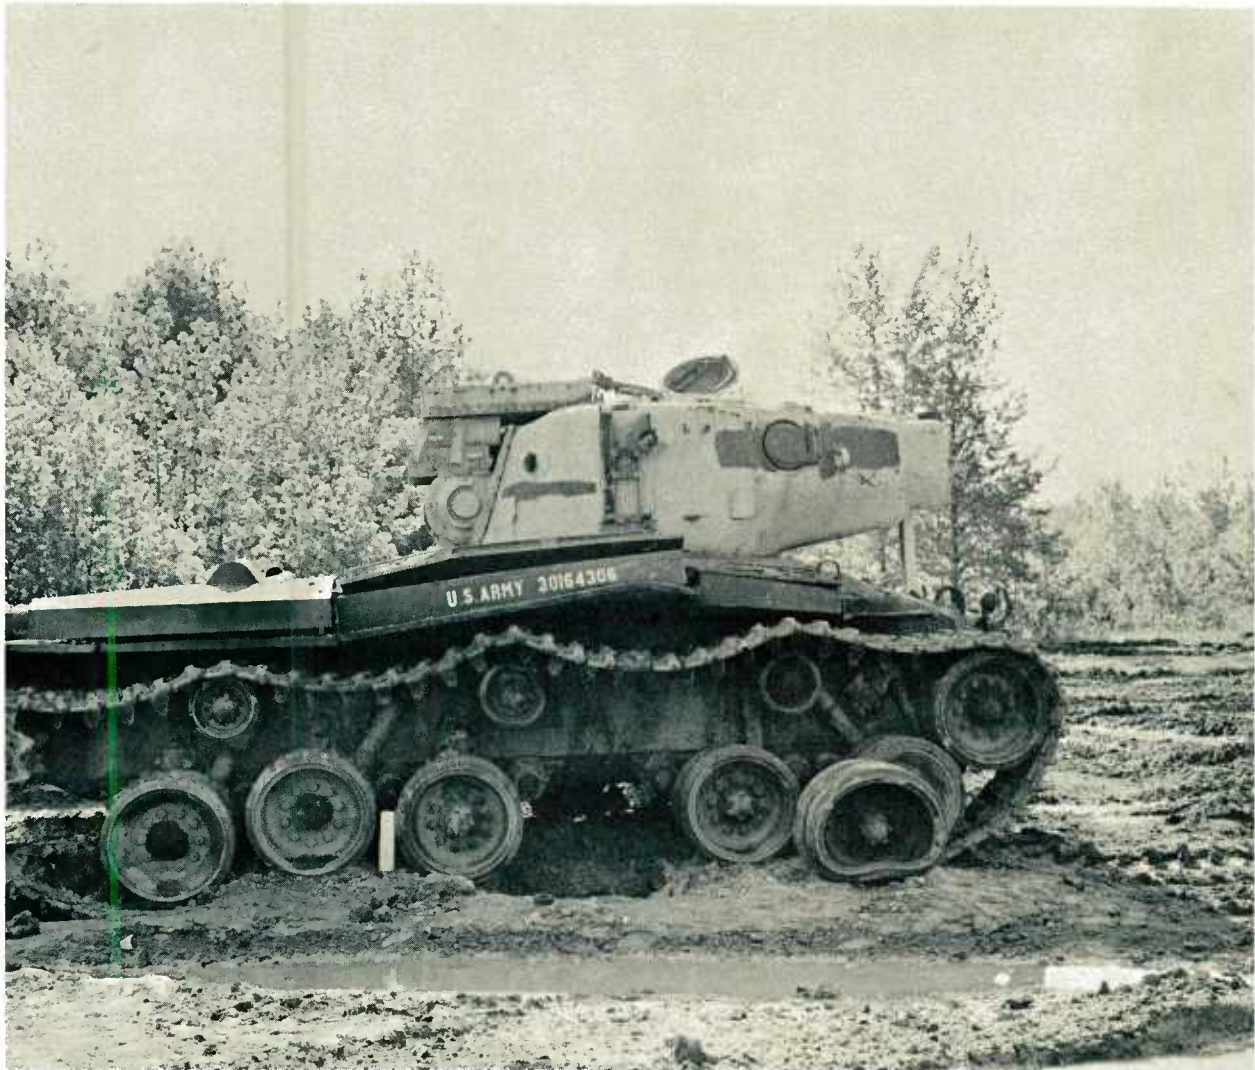
59T1855: General View of Right Side of U.S. M47 Tank, No. 30164306 After Detonation of Charge No. 22 Under Centerline of No. 3 Road Wheel Under Lateral Center of the JSIII Tank Track. Charge Consisted of 2.98 Pounds of H6 Encased in an 8.5-Inch Diameter Cylindrical 24-Gauge Galvanized Container. Emplaced with 3-Inch Soil Cover.
